ASAHI/AMERICA, INC.

URGENT: Lever- and Gear-operated Pool-Pro™ and Type-57P Butterfly Valve Manufacturing Issue Notification

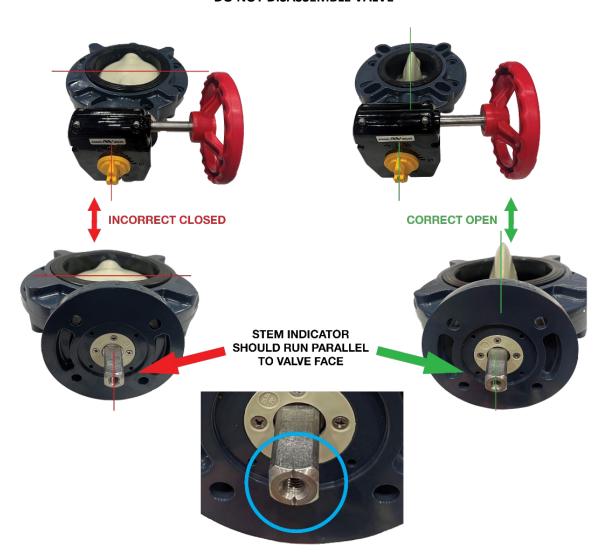
We have recently become aware that during the assembly process for some of these valves, the stem may have been improperly installed and were not detected in final QC inspection. In some cases, the stem was installed into the disc incorrectly whereby the open/close indicator on the stem was incorrectly aligned to the relative position of the disc within the body of the valve, i.e. rotated 90 degrees that would result in improper indication to the position of the disc.

- Lever: Inspect valve by removing the Lever, if necessary, and then match the disc position with the line indicator on the stem of the valve
- Gear: Inspect the gear operator indicator to match the disc position (Please see pictures below for your reference)

DO NOT DISASSEMBLE VALVE

For assistance in determining disc orientation with stem, contact your District Sales Manager. Please contact Asahi/America, Inc. at 800-343-3618 for any corrective actions required.
